Days River Watershed Management Plan

September 2006

Delta Conservation District
2003 Minneapolis Ave
Gladstone, MI 49837
906-428-4076

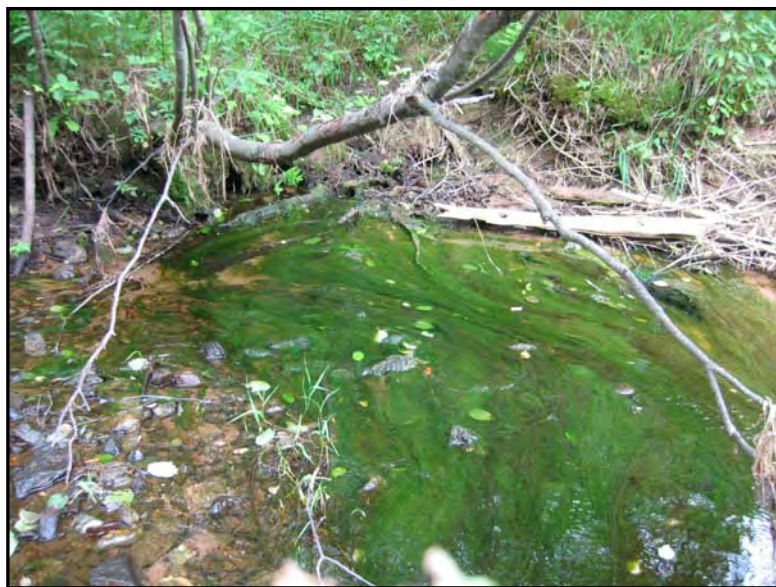
Figure 11 Source of algae, nutrients from suspected failing septic system

Water sample testing needs to be done to determine the amounts nutrients available within the Days River waterways. Based on visual observation only two areas of the Days River appeared to be affected by excess nutrient loading. This is based on increased algae growth. Both areas are suspected to originate from a failing septic system and a sewage lagoon. Based on visual observations there appears to be little if any impact from agricultural sources. Landscaped lawns mowed right up to the streambanks edge contribute to both lawn fertilizer runoff into the stream and a lack of a vegetative buffer along the river. Vegetative buffers serve several purposes. One such purpose is to utilize nutrients before it runs off into the stream and provide root structure within the stream bank reducing soil loss from erosion.

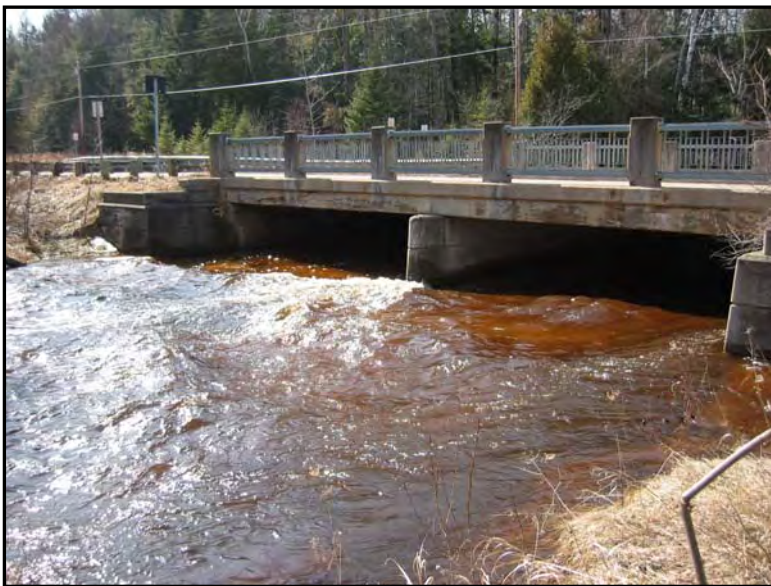
Figure 19 Kipling road bridge DR01

Two of the road stream crossings were considered in poor condition. Both of these crossings belong to the Michigan Department of Natural Resources. They are located within the Days River Pathway Recreational Area. One bridge was a crossing for cross-country skiers and mountain bikers. This bridge has since been removed due to structural concerns, but there are plans for it to be replaced. The second bridge, Mini Mac, is a crossing for the snowmobile trail. Both bridges contribute large amounts of sand to the small tributary. During the stream survey it was determined that the sand sediments ended shortly upstream of the last bridge. A large majority of the sand that is entering the stream is coming from the approach trails.

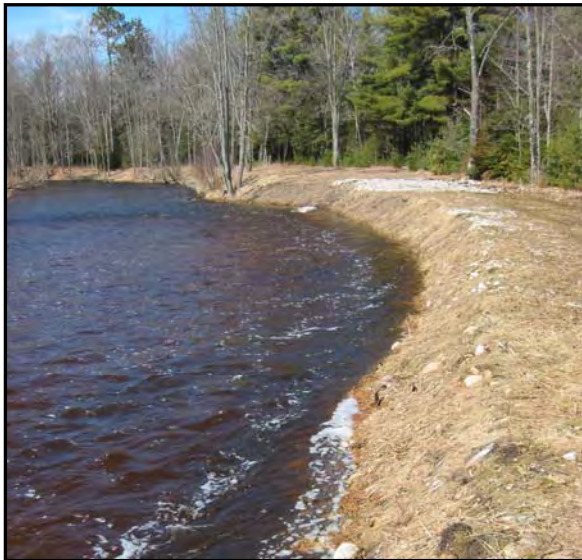
Figure 31 Gabions removed from bank for overflow channel

The MDNR has installed 300 ft. of Rock Rip Rap along the bank of the Days River to prevent the potential loss of a home. This bank has been cut back over 15 feet in the past three years. The site was declared an emergency site and was funded to help repair the bank. Rock filled gabions were also removed up stream to help reestablish an old overflow channel.

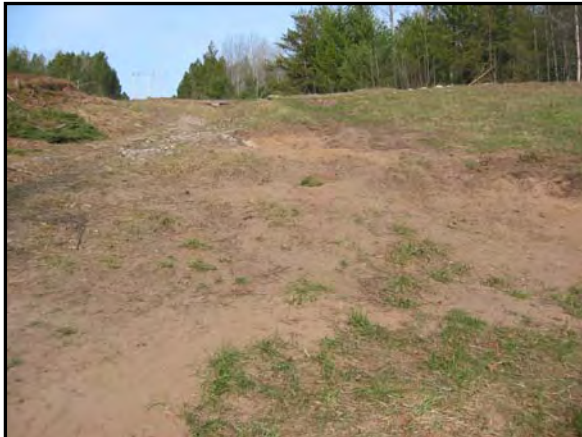
Figure 33 ORV 1 Site Before

The MDNR has also done some restoration and improvement work of the ORV 1 site. The damage to this bank is due to a severe slope, runoff from the slope above, soils, and unauthorized ORV traffic. The local MDNR applied for funding through the ORV trail monies to repair damage to the bank and attempt to stop the ORV use. This project included restoration of the streambank to prevent ORV traffic, bank stabilization due to groundwater seeps, and stabilization of the lamprey weir.
